MEMORANDUM

Project: 090557-01

Re: Post-TCRA Quarterly Inspection Report - April 2012 Inspection

This document reports the results of the inspection conducted in April 2012 at the San Jacinto River Waste Pits (SJRWPs) for the protective cover, fencing, and signage installed for the Time Critical Removal Action (TCRA).

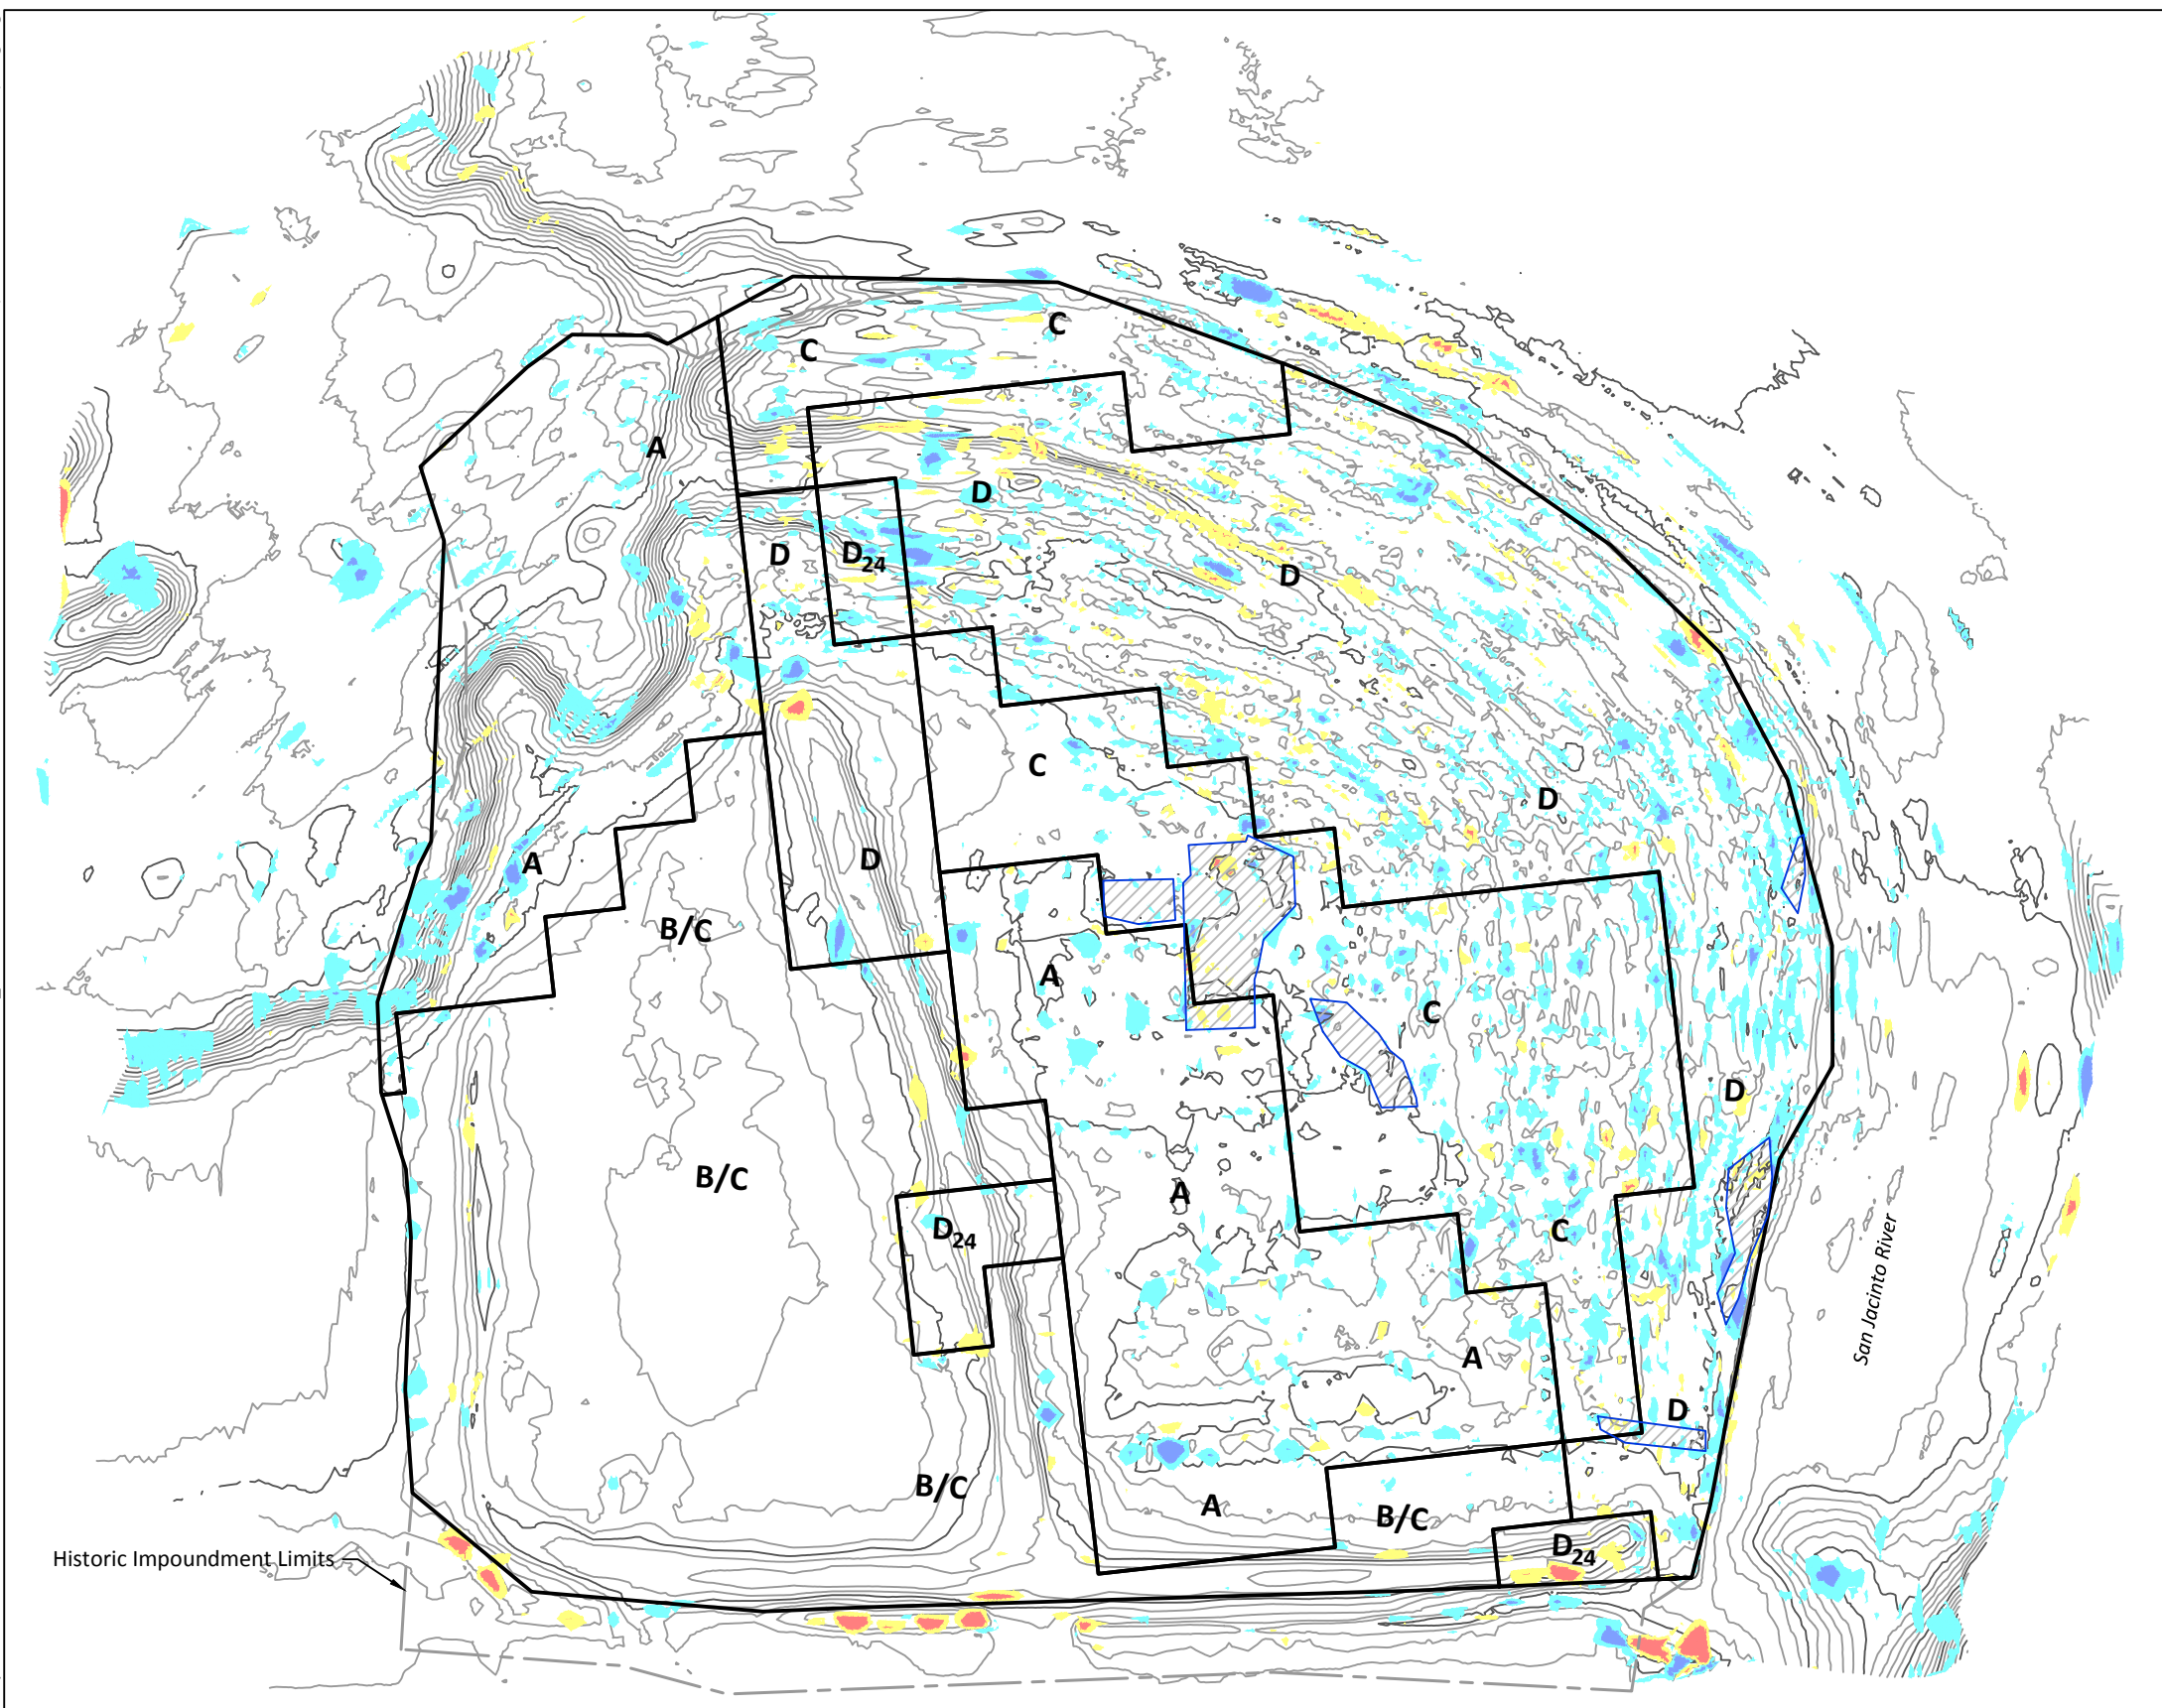
The survey for this quarterly inspection event was conducted by Hydrographic Consultants, Ltd. between April 13, 2012 and April 26, 2012. The survey event took 13 days to complete due to seasonal tides and weather delays. Figure 3 displays the results of the completed survey.

This survey dataset was compared to the previous quarterly inspection survey² to evaluate the differences in the top of armor cap elevation between surveys. These differences are shown on Figure 3.

The threshold limits established by the OMM Plan (± 0.5 foot over a 30 foot by 30 foot area) were not exceeded and probing was not required.

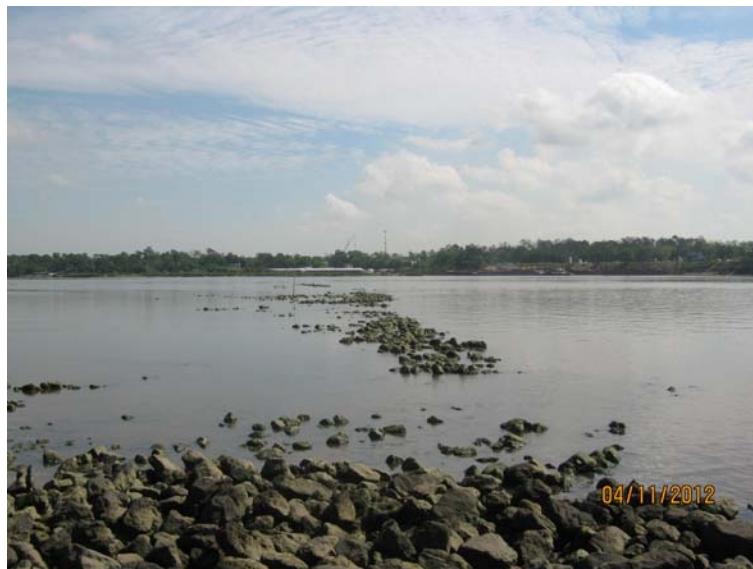
The upland portions of the armored cap were visually inspected on April 11, 2012. Photographs from the inspection event are provided in Appendix A (Photographs 01 through 14). None of the visible portions of the armored cap were identified as having been breached or otherwise damaged. No movement or erosion of waste materials into the San Jacinto River was observed; the eastern edge of the armored cap was observable above the water line (Photograph 03) and the eastern edge appeared to be unchanged from the previous inspection.

Photo 03: Eastern edge of the armored cap (thickened edge) visible above the water line (view northeast)

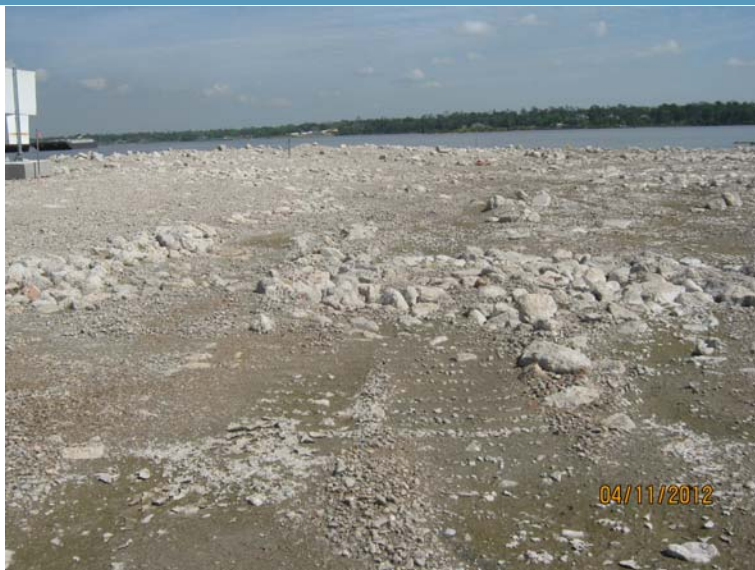
Photo 13: Track from Morooka truck used during TCRA construction still visible in the surface of the cap in the Western Cell (view northwest)

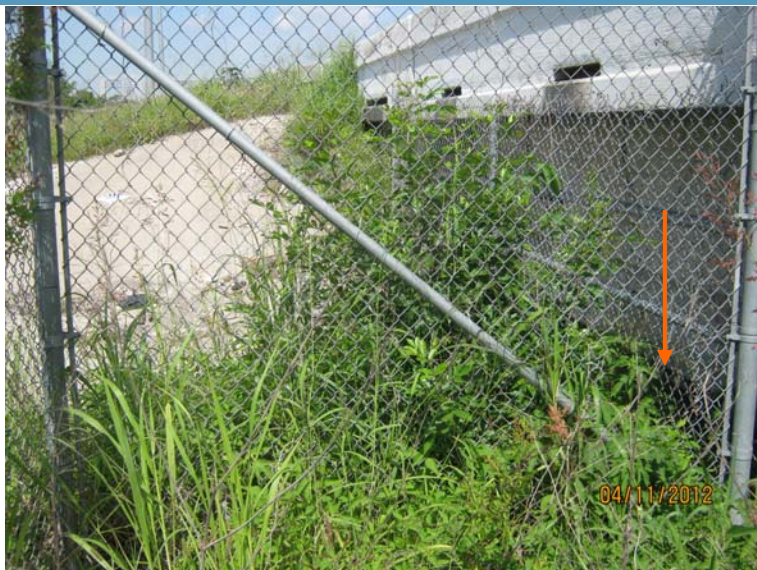
One breach was observed in the fence on the west bank on the south side of I-10. The breach was located at the very west end of the perimeter fence and was approximately 18-inches by 24-inches in size (Appendix A, Photographs 25 through 27). Repairs were made by fitting additional chain link fencing to the original perimeter fence (Appendix A, Photographs 28 and 29). Following the repair of the 18-inch by 24-inch breach, all of the perimeter fence is intact.

Photo 25: 18-inch x 24-inch fence breach observed at western end of the perimeter fence south of I-10 (view west)

The visual inspection event did not identify damaged or otherwise deficient areas in the armored cap or signage. One breach was observed in the perimeter fence, approximately 18-inches by 24-inches in size, on the west bank on the south side of I-10; this breach was repaired on April 16, 2012. The “No Trespassing” signs positioned around the Western Cell were reoriented during the inspection. No further repair requirements were identified.

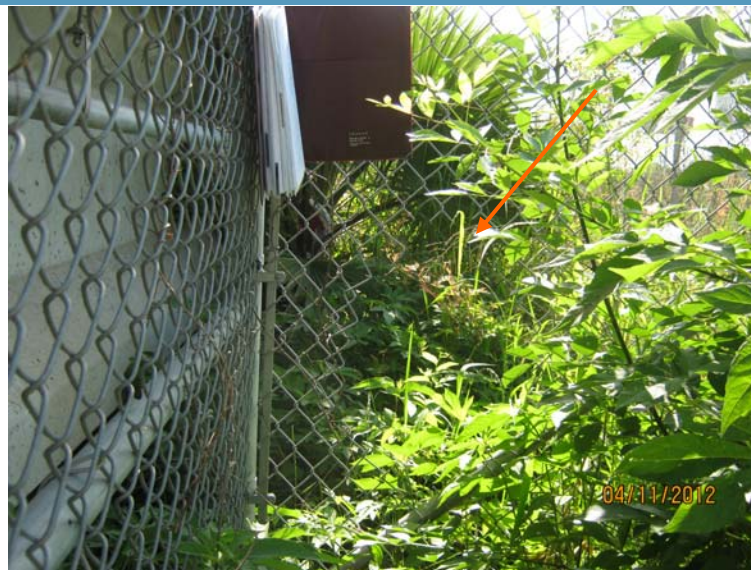
Photo 26: 18-inch x 24-inch fence breach observed at western end of the perimeter fence south of I-10 (view east, binder in photo to provide scale)

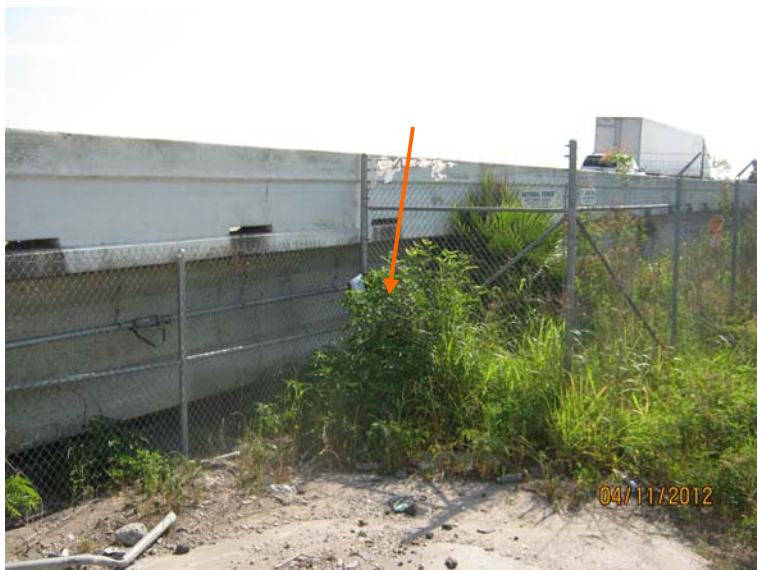
Because this is the second instance of a fence breach at this location (the west end of the perimeter fence was also repaired in December 2011), the Respondents also contacted Harris County Sheriff's Office on April 24, 2012, and requested an increase in patrols at this location on weekends.

Photo 27: Location of observed fence breach at western end of the perimeter fence south of I-10 (view northeast)

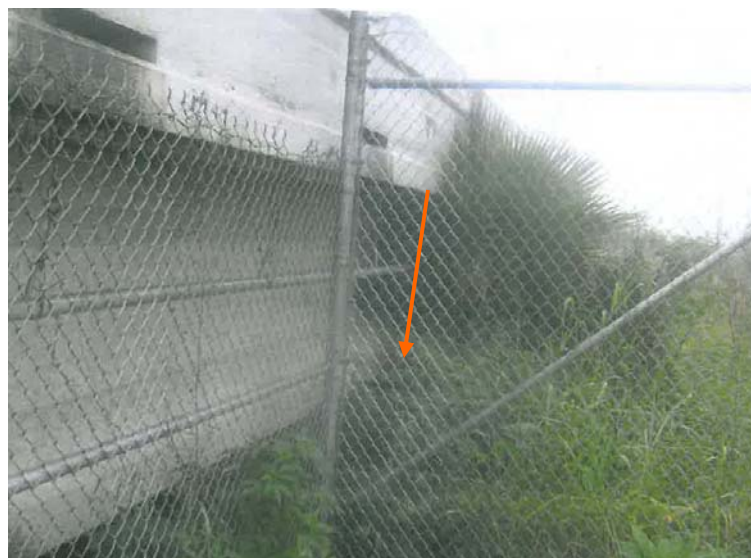
Photo 28: Repaired section of the perimeter fence at western end south of I-10 (view east)

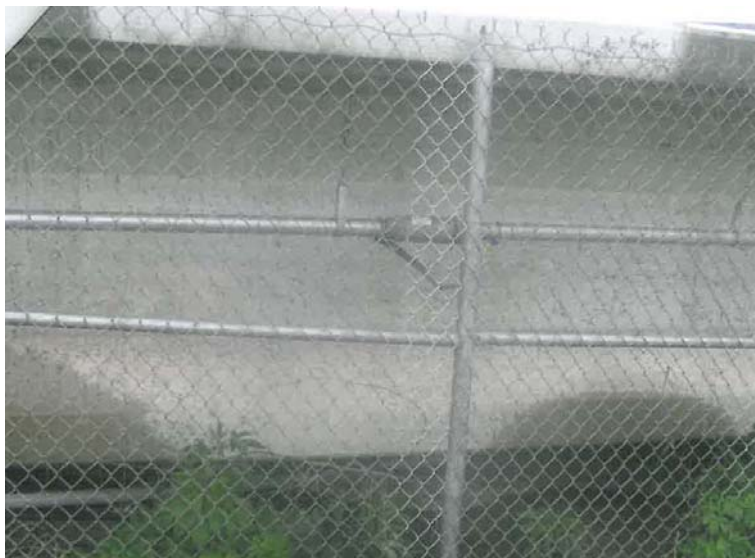
Photo 29: Repaired section of the perimeter fence at western end south of I-10 (view north)
